Expanded Site Screening North East Church Rock – Quivira Mines Navajo Nation, New Mexico

April 2010

Weston Solutions, Inc. 428 Thirteenth Street, 6th Floor, Suite B Oakland, CA 94612

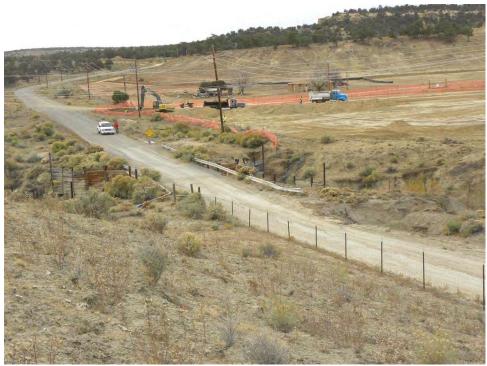
Photo 1. Road and bridge separating NE Church Rock and NE Church Rock 1

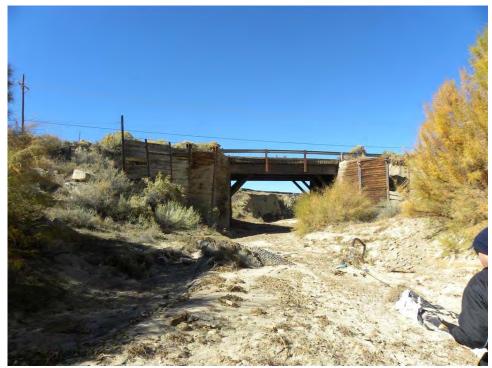
Photo 9. Bridge crossing arroyo between NE Church Rock and NE Church Rock 1
